NATIONAL EMISSION STANDARDS FOR HAZARDOUS AIR POLLUTANTS (NESHAP) ASBESTOS - REVISION

CURIEL PRIMARY SCHOOL – CAMPUS ROOF RESTORATIONS AND BUILDING WEATHERIZATION PROJECT

1000 North Curiel Street
Eloy, Arizona
WT Reference No. 2188JH269

September 24, 2019

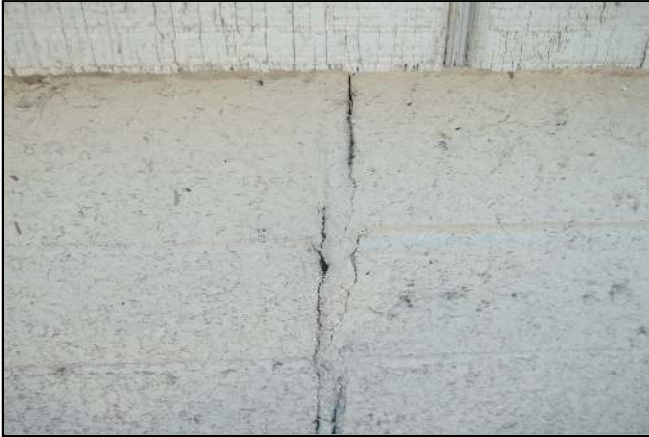
Picture 1 – Expansion joint in masonry walls, typical.

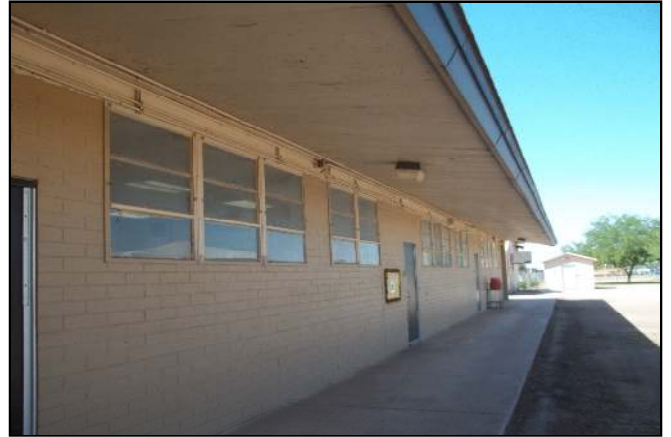
Picture 2 – Exterior exposed window walls.

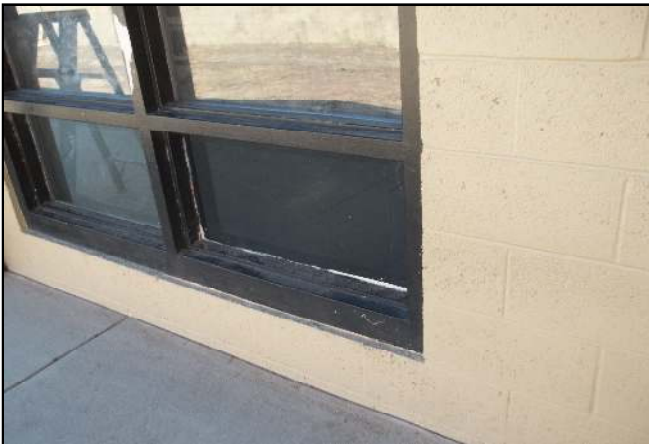
Picture 3 – Sealant between window frames and masonry, typical.

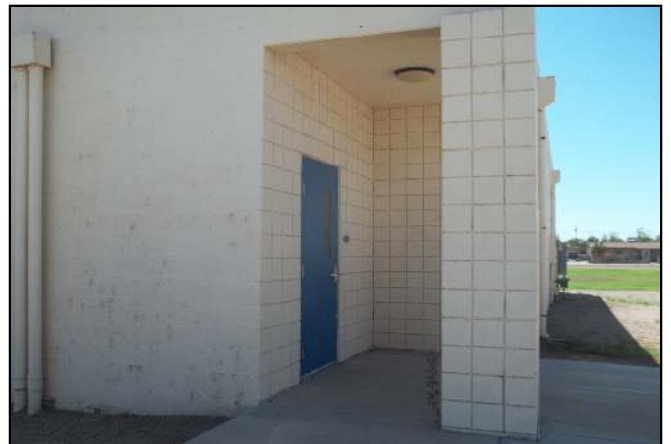
Picture 4 – Sealant around door in the Gymnasium.

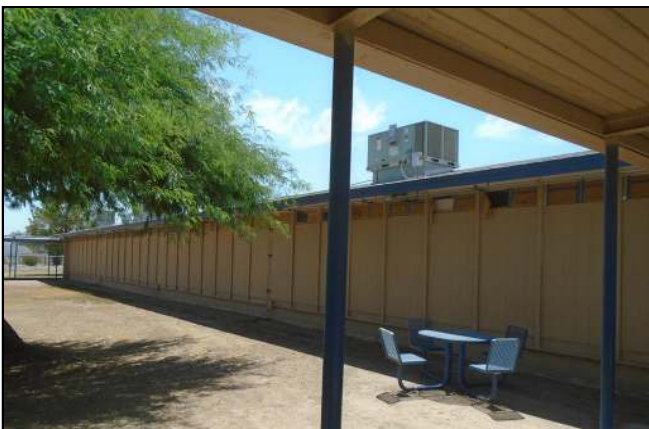
Picture 5 – Window walls suspected to be located underneath wood panels.

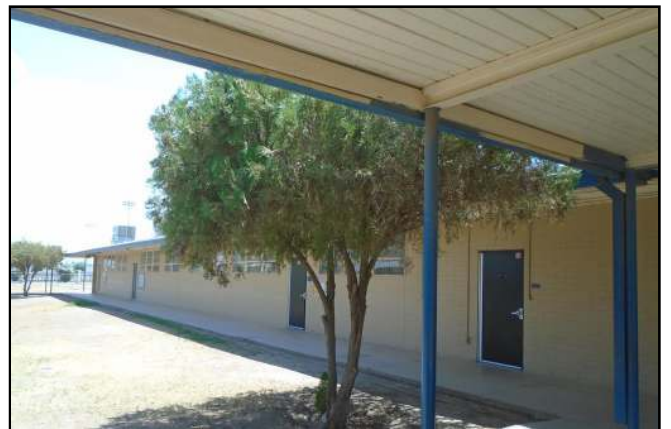
Picture 6 – Doors with sealant between frames and masonry, typical.
