NATIONAL EMISSION STANDARDS FOR HAZARDOUS AIR POLLUTANTS (NESHAP) ASBESTOS

CURIEL PRIMARY SCHOOL – CAMPUS ROOF RESTORATIONS AND BUILDING WEATHERIZATION PROJECT

1000 North Curiel Street
Eloy, Arizona
WT Reference No. 2188JH269

August 10, 2018

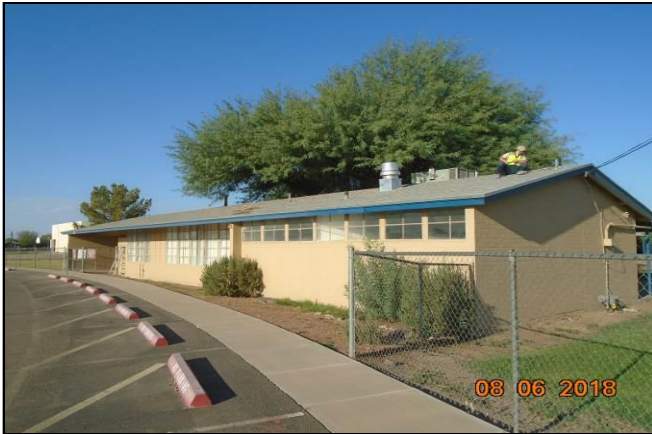
Picture 1 – General view of Building 5.

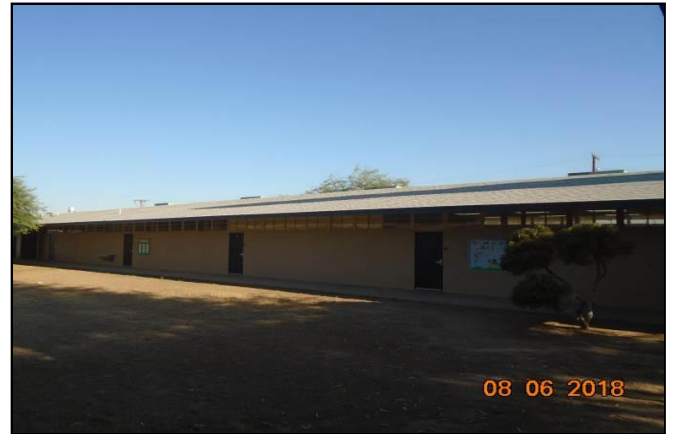
Picture 2 – Building 6 and 7, and general lay-out of Buildings 8 through 13.

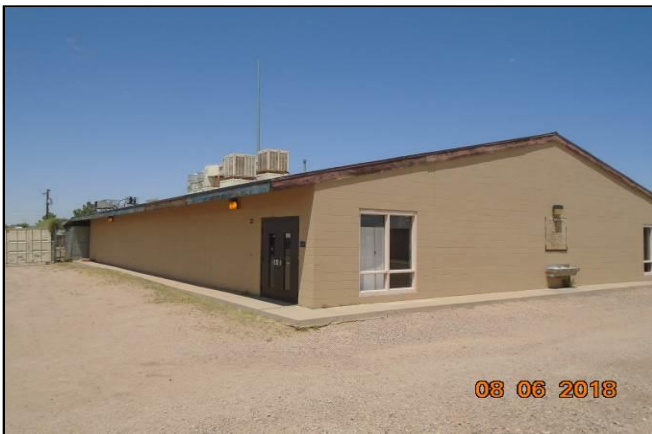
Picture 3 – General view of Building 14.

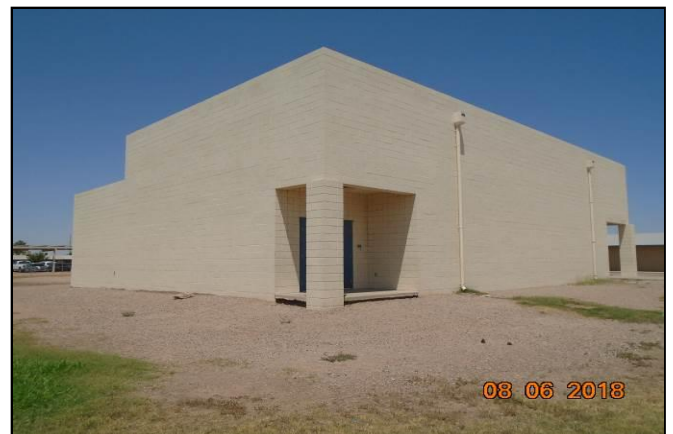
Picture 4 – General view of the Gymnasium.

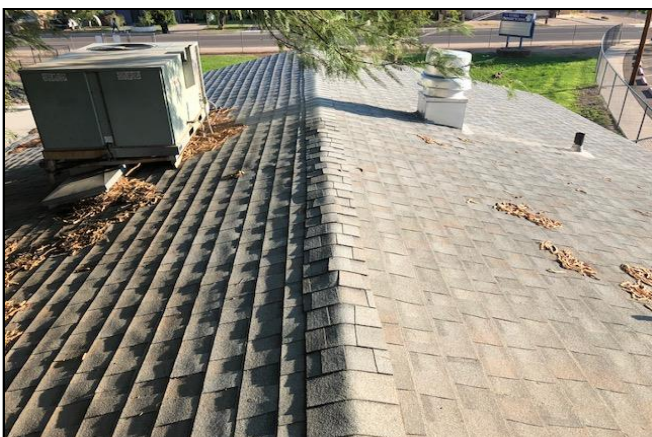
Picture 5 – Asphalt shingles and felt roofing system found on Buildings 5 through 14.

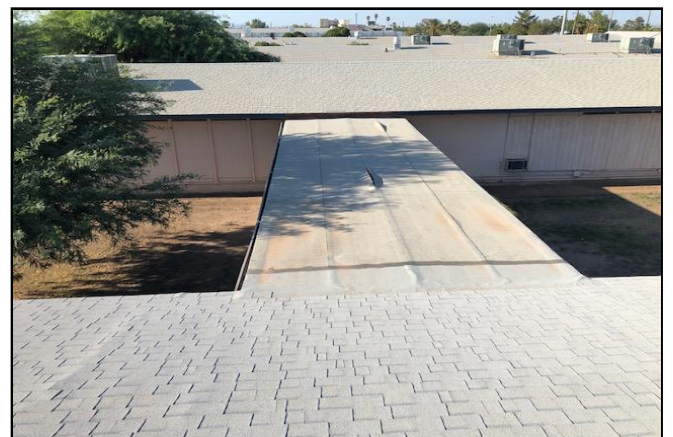
Picture 6 – Breezeway found connecting Buildings 5 through 13.

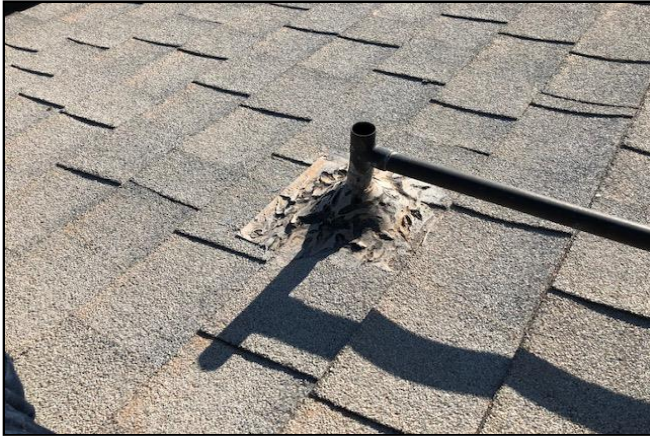
The asbestos containing roof sealant is a non-friable material that appeared in good condition at the time of the inspection. Removal of the roof sealant is deregulated by OSHA and categorized by NESHAP as Category II, non-friable. These materials will not become friable during removal and do not trigger a NESHAP notification.

Picture 7 – Black roof penetration sealant found on buildings 5 though 14 and the Gymnasium.

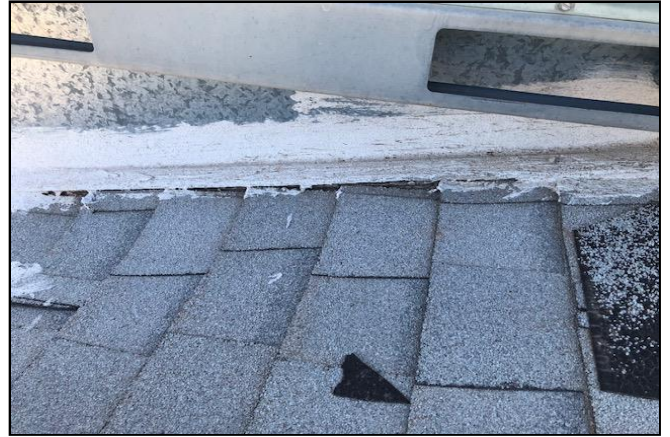
Picture 8 – White roof sealant on HVAC systems on buildings 5 through 14 and the Gymnasium.

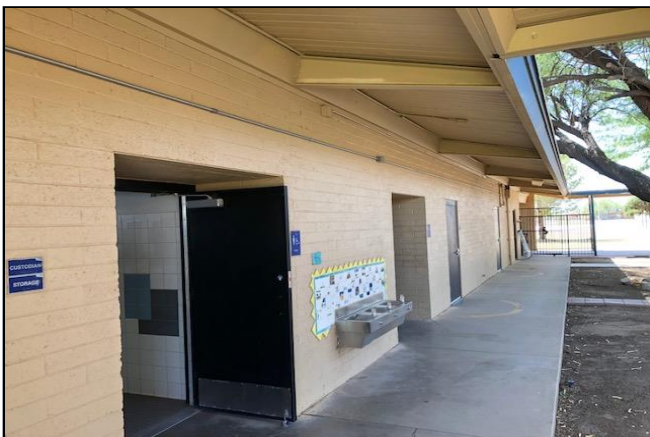
Picture 9 – Concrete block and mortar exterior walls on buildings 5 though 14.

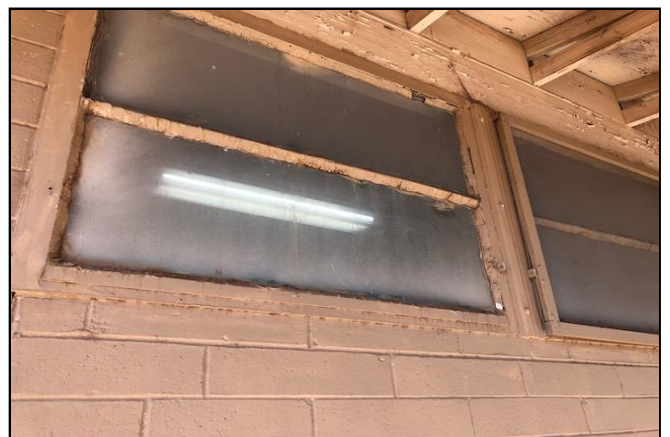
Picture 10 - Window glazing found on buildings 12 and 13.

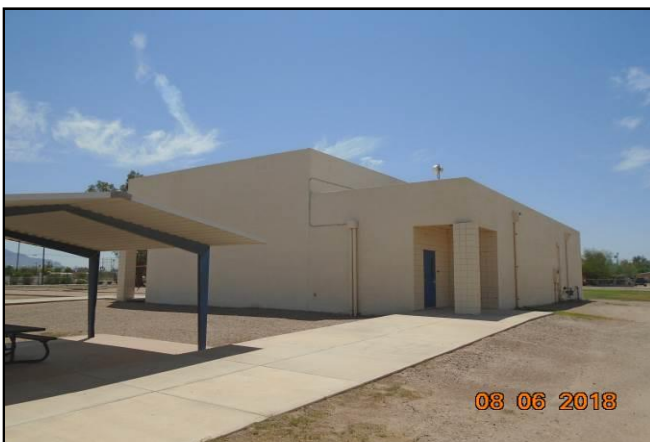
Picture 11 - Picture 10 – Concrete block and mortar exterior walls with white paint found on the Gymnasium

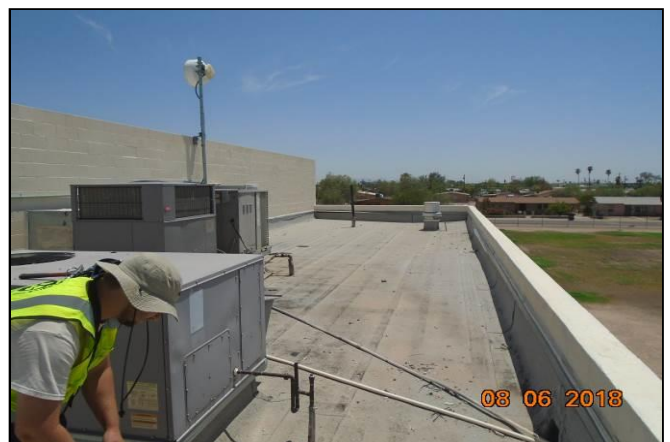
Picture 12 – View of lower roof of the Gymnasium.
